MITIGATION OF SLOPE FAILURE

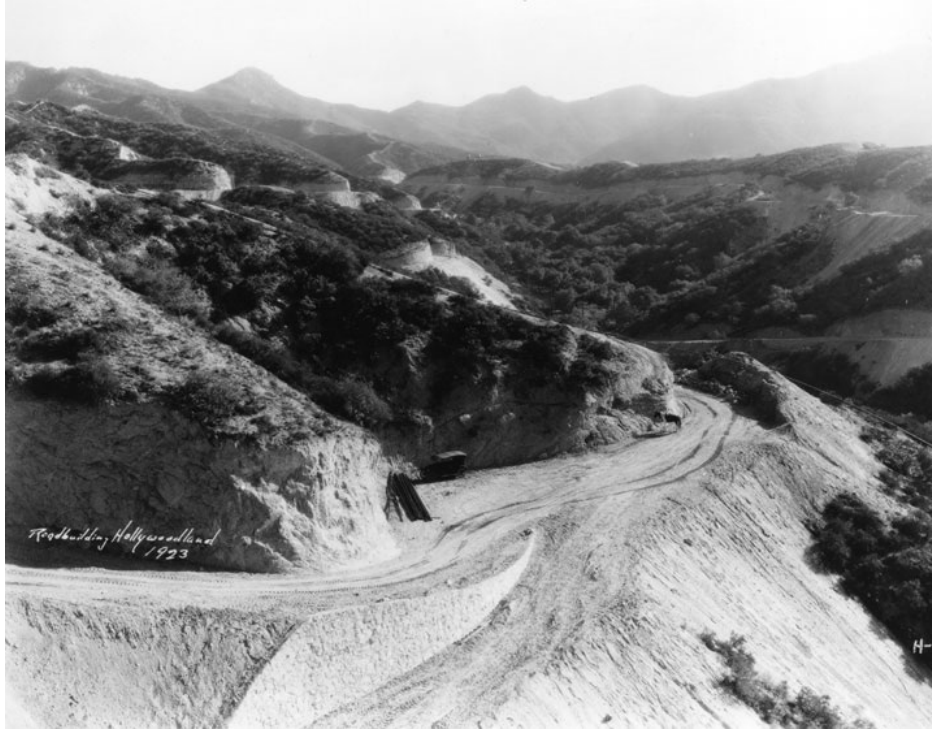
Photo 1: Steep slopes for road construction, 1923

Much of the developments in the hillside areas were constructed a long time ago, with building booms in the 1920s and after WWII in the late 1940s and early 1950s. Slopes were commonly graded with very steep gradients, primarily to construct roads (see Photos 1 and 2 below). Grading regulations were not part of the building Code at that time. Roads were constructed by grading very steep slopes, many of which remain to this day. When heavy rains occurred in 1952 (which was preceded with about 10 years of drought), landslides and mud flows damaged many properties all over the hillside areas of the City. This inspired the development of the nation's first grading code requirements. Hillside development after approval of the grading ordinance in late 1952 required grading permits, the input of a soils engineer, less steep slope gradients and other regulations. The purpose of this code is to safeguard life, limb, property and the public welfare by regulating grading on private property. Concurrent with the establishment of the grading code requirements, the Los Angeles Department of Building and Safety (LADBS) established a Grading Division, which was charged with administering the new code. Subsequent revisions of the grading code required the input of engineering geologists, building setbacks from slopes, paved drainage devices for slopes, and planting of graded slopes; all by 1960.

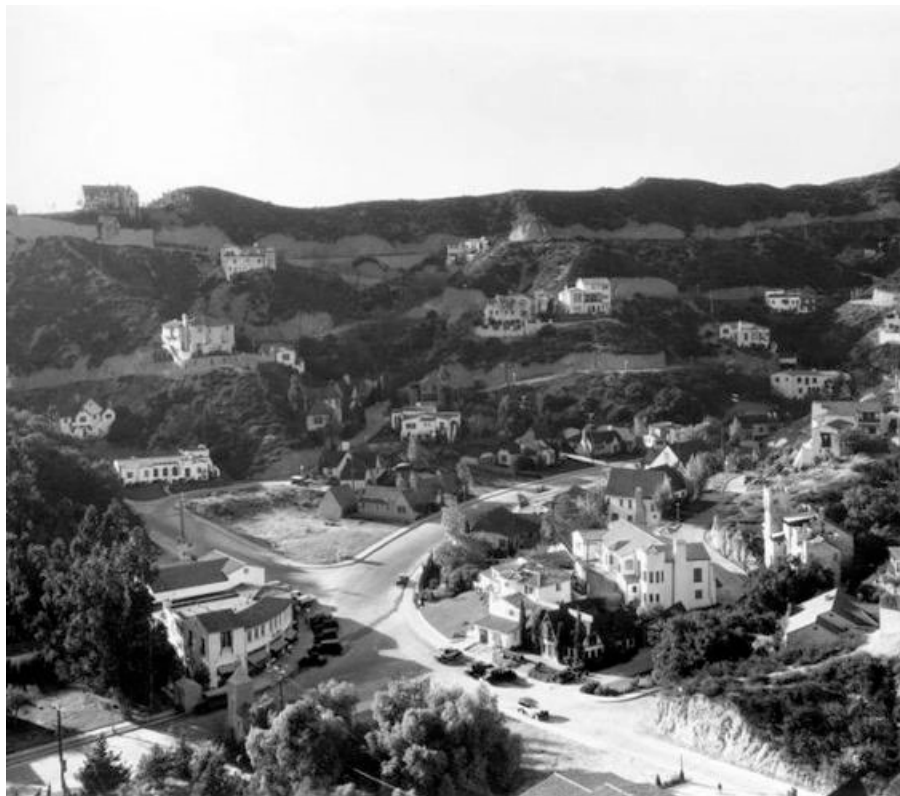
Photo 2: Development around 1928. Note the steep road cuts.

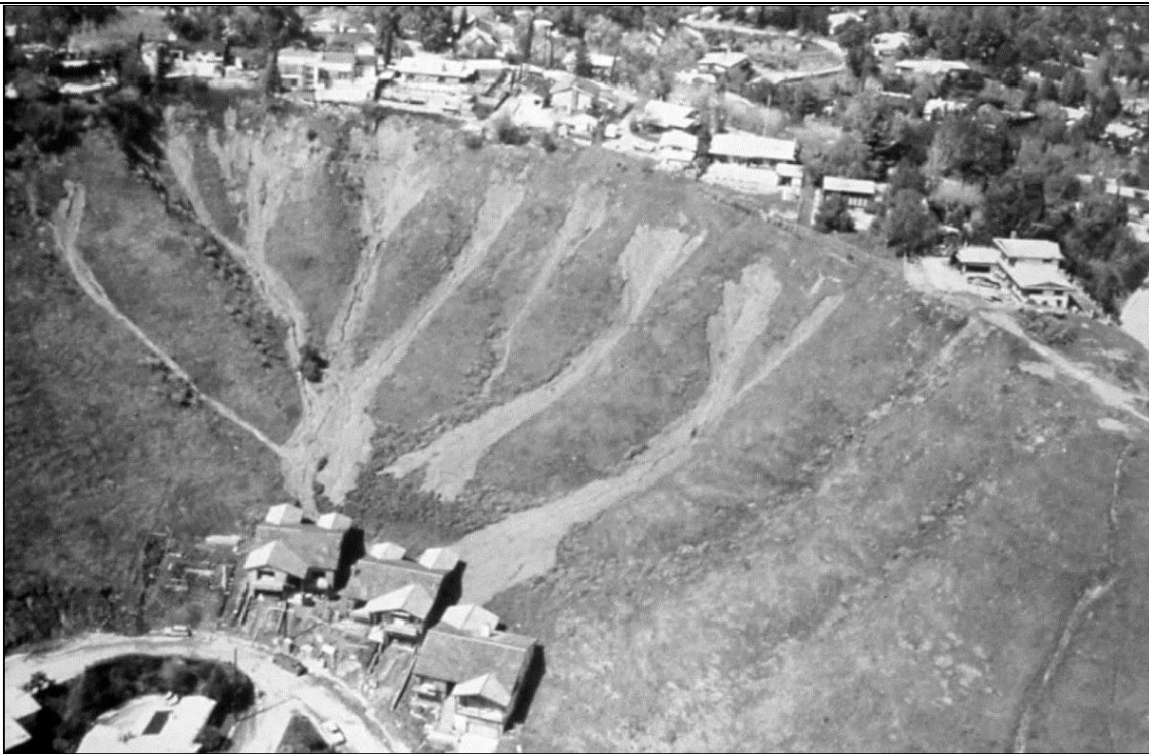
Photo 3: Typical soil slips/mudflows originating from topographic swales on steep slopes. This type of failure is particularly dangerous for rear bedrooms facing the bottom of the slope.

The most destructive type of slope failures are mudflows, also referred to as debris flows, and soil slips or slumps (see Photo 3). These occur when soil becomes saturated from abundant rainfall on steep slopes. They usually happen without warning and can move with destructive force down to the bottom of the slope. Photo 4 shows an example of a mudflow.

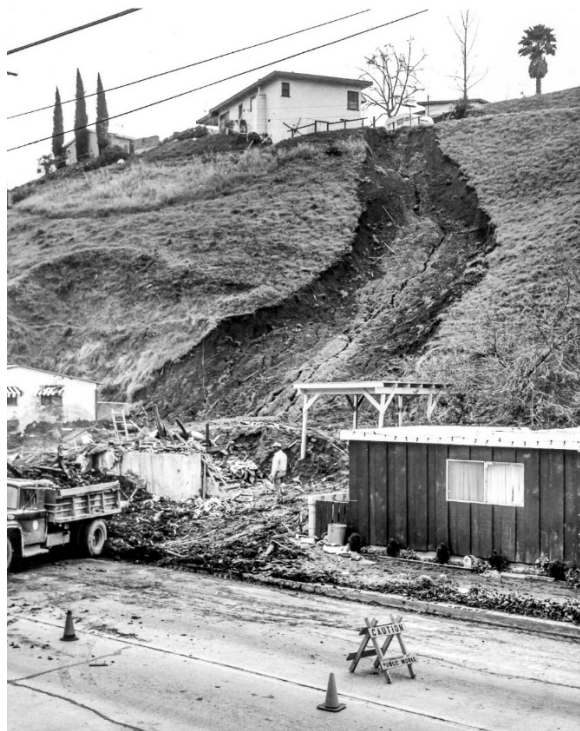
Photo 4: Soil slip/mudflow

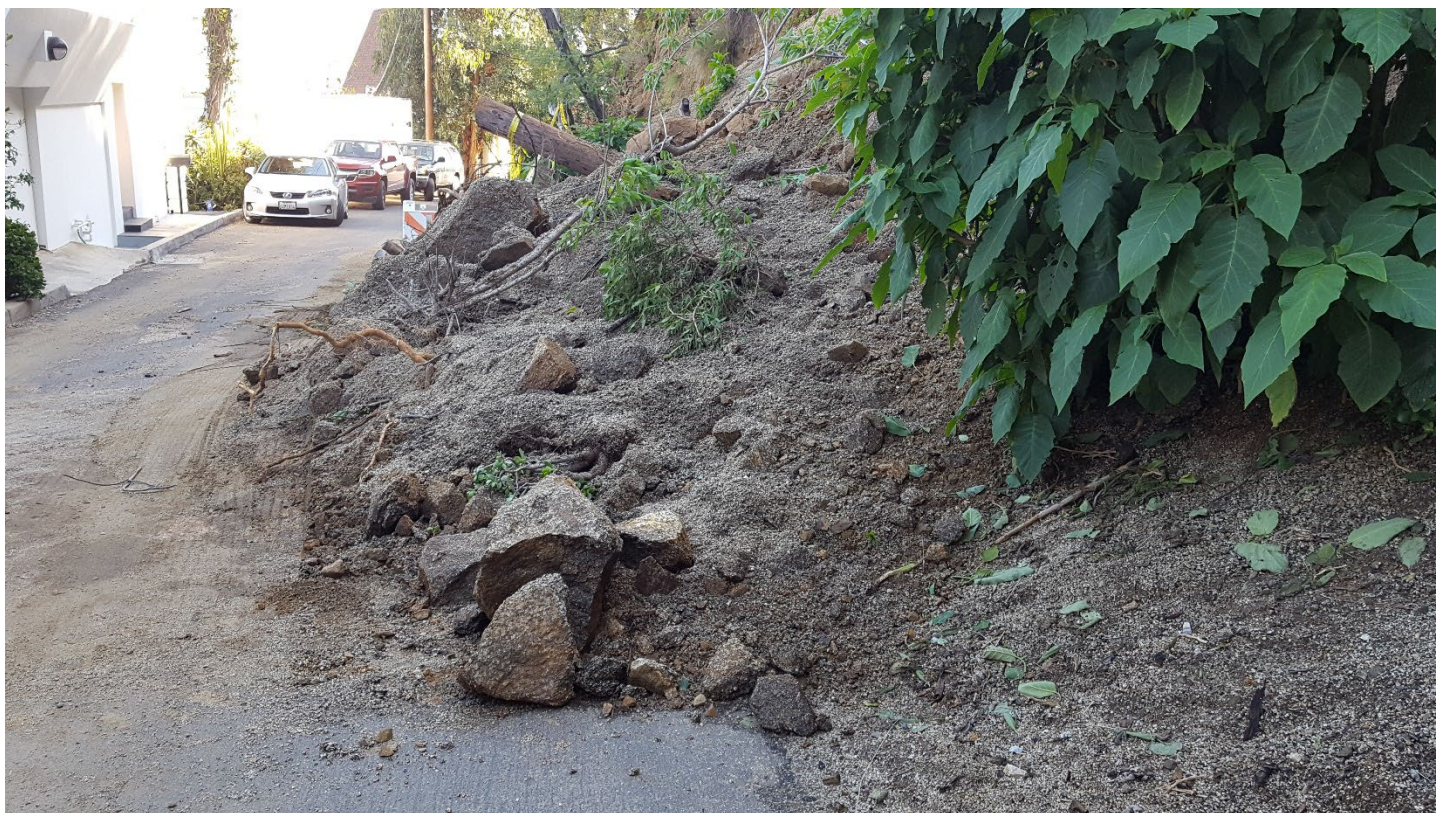
Photo 5: Rockfall from granitic rock

Rock falls occur where bedrock is exposed on steep slopes. Usually rock masses contain fractures and other planes of weakness that if become saturated can fail. The falling rock fragments can remain intact (remain as large pieces), or become pulverized with the start of movement. (see photo 5).

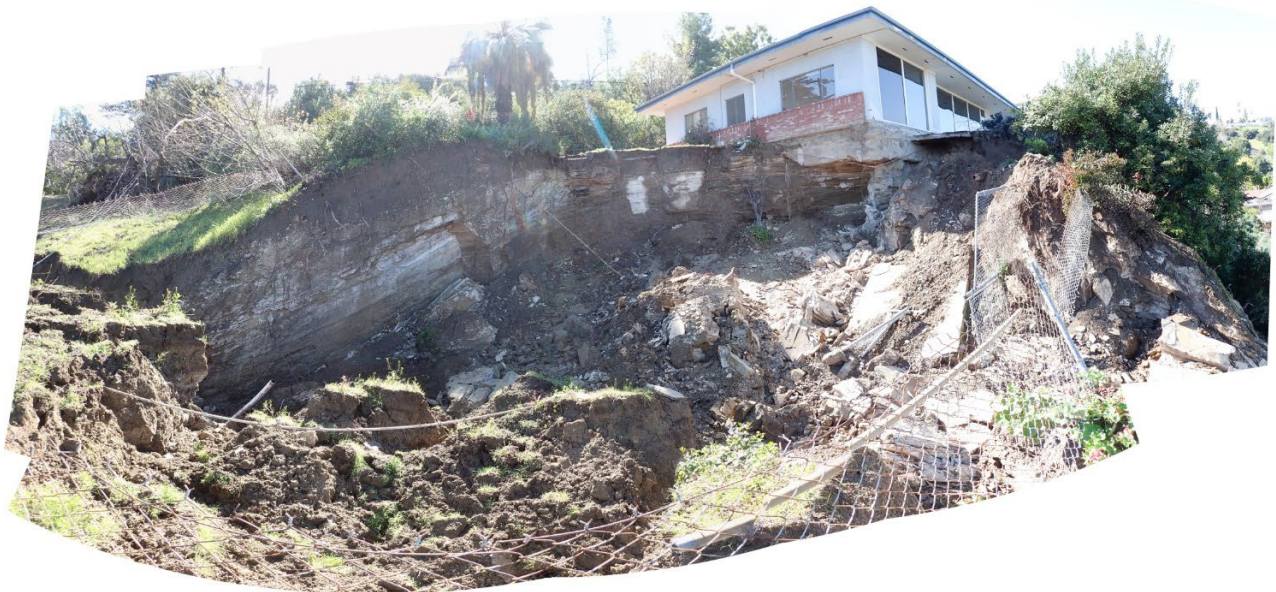
Photo 6: Landslide involving layered sedimentary bedrock, 2024

Landslides consist of deeper slope failures that usually involve bedrock, either exposed or covered by soil. These failures are typically slower than the surficial mudflow failures described above. Some of these landslides are reactivation of ancient slides that may not have been previously recognized. While the size of these massive landslides varies, they can be quite large and extend to several properties. These larger landslides can activate after the storm event, and even after the rainy season. This is because it takes time for the rain water to percolate deep enough to where potential slide planes exist. (see Photo 6).

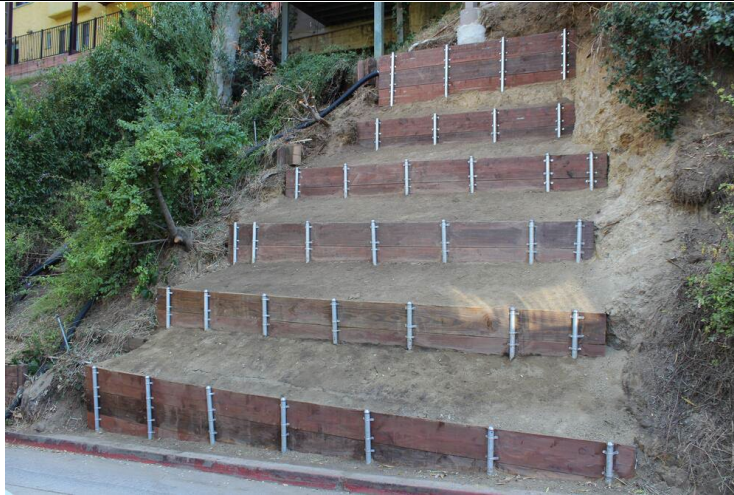
Photo 9: A surficial failure repaired using the pipe-and-board method.

Minor soils slips may be able to be repaired using the pipe and board method where the slope is too steep to leave as is, where erosion and future soil slips are still possible (see Photo 9). The LADBS may consider pipe and board methods as "remedial" because, while not discussed in the building code, they improve the site condition and won't involve building new structures, including conventional retaining walls. A permit to construct a pipe-and-board system is required.

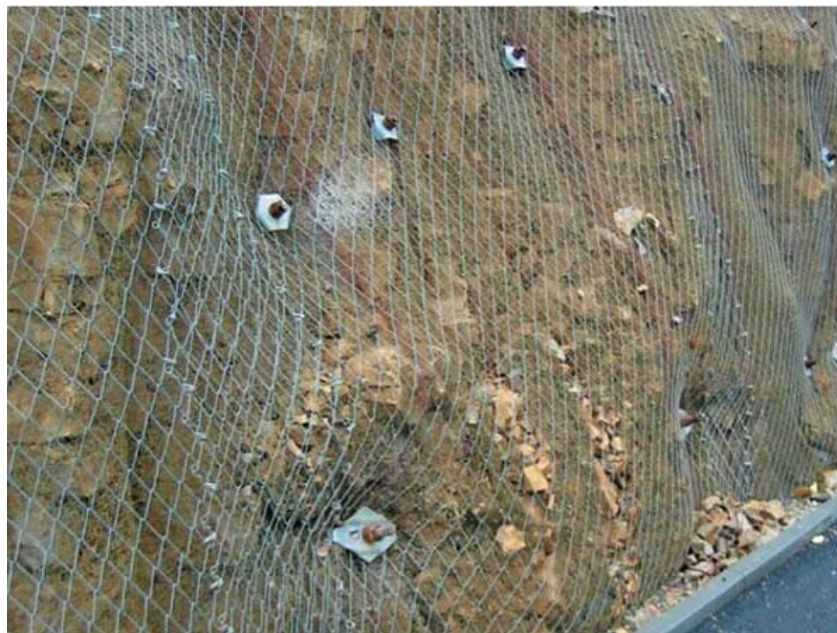
Photo 10: An unstable rock slope repaired with anchored steel mesh.

Another mitigation/repair method that is not in the building code and only approved and permitted on a remedial basis, is anchored netting, where there is rock fall potential (see photo 10). This is a good alternative where steep slopes (45 degrees or steeper) cannot be trimmed to a code-compliant gradient because of property line constraints or such trimming would eliminate the building pad. This involves anchoring (with rock bolts or “soil” nails for deeper potential failures) a strong steel mesh against the slope.

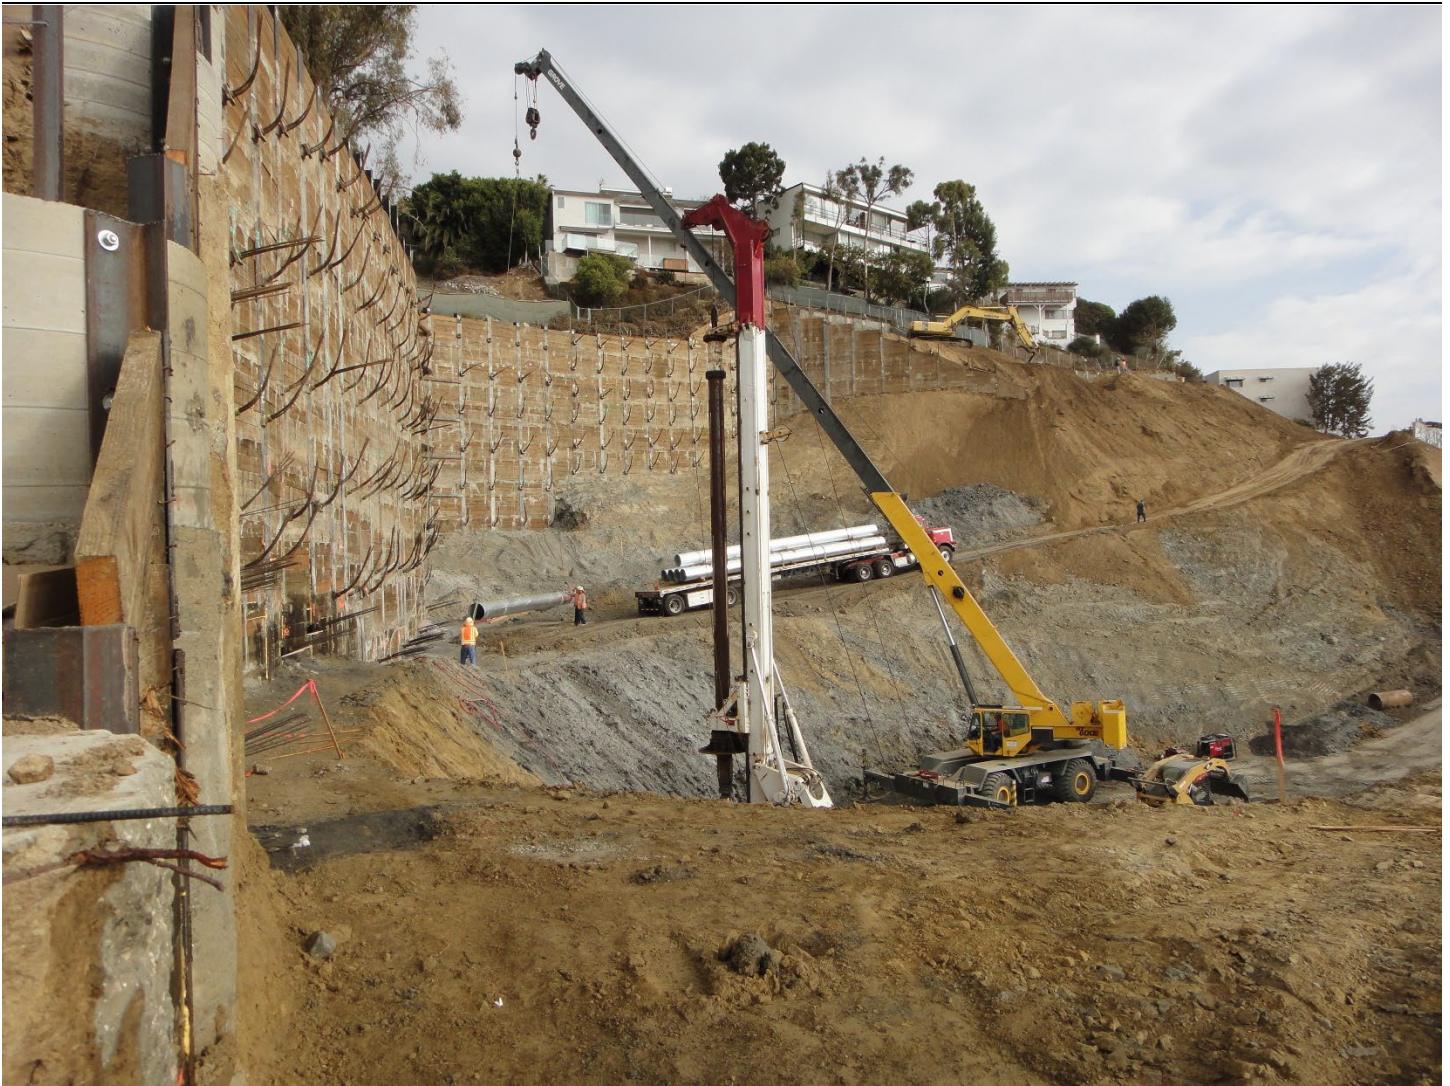
Photo 11: A major landslide repair in progress using grading, soldier piles and retaining walls.

To repair larger and deeper landslides, which typically involve underlying bedrock and may extend beyond any one property, requires considerably more effort. Typical mitigation involves extensive grading and/or soldier piles (reinforcing piles) including retaining walls (see photo 11).
